EVALUATION OF FUTURE FUELS IN A HIGH PRESSURE COMMON RAIL SYSTEM – PART 3 JOHN DEERE 4.5L POWERTECH PLUS

INTERIM REPORT TFLRF No. 433

U.S. Army TARDEC Fuels and Lubricants Research Facility Southwest Research Institute® (SwRI®)
San Antonio, TX

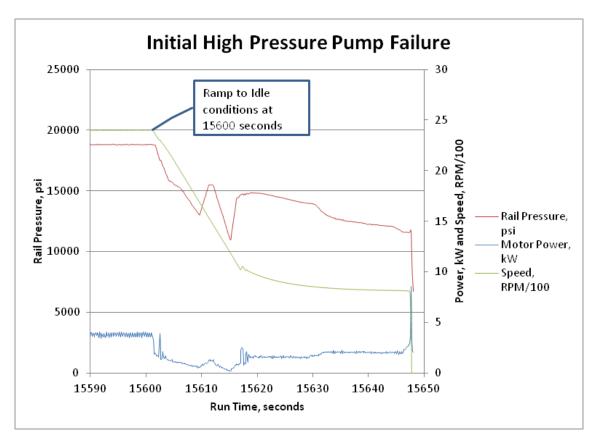
Figure 17. Initial High Pressure Pump Failure

The first fuel to experience a failure of the high pressure pump was the 93.3°C SPK with 9 ppm DCI-4A. When a failure occurs, of which the physical process is discussed in section 3.4, the data acquisition system stores the information immediately preceding a shutdown at a rate of 10Hz rather than the slower logging rate commonly used for durability testing. This allows for post-failure analysis at an improved resolution. Figure 17 shows this data from the first pump using 93.3°C SPK with 9 ppm DCI-4A.

Data shown is for Step 5 of the NATO Cycle, four minutes of idle conditions followed by six minutes of rated conditions with a specified moving command of three seconds. While the command was over three seconds, controller lag within the VFD and the rotational inertia within of the system flywheel result in a change of speed much slower than this. Between 15640 and 15650 seconds, the motor power can be seen to spike as the speed rapidly dropped. The rail pressure follows the loss of speed as no additional fuel was being imparted to the rail. Following this test, being the first failure witnessed, it was decided to replace the high pressure pump and restart testing with the same fuel as a confirmation of the problem. A similar failure occurred which is shown in Figure 18.

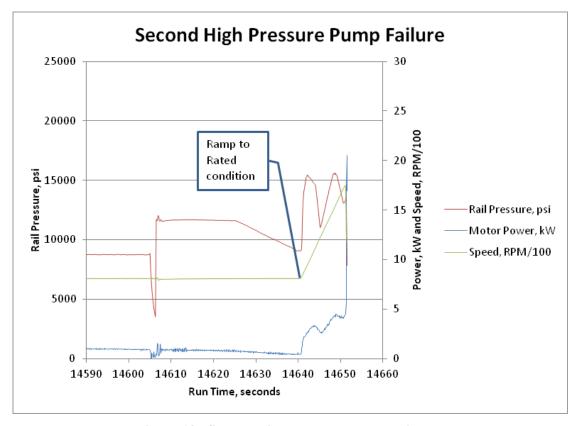
Figure 18. Second High Pressure Pump Failure

Unlike the first failure, the second pump stopped functioning during the ramp from idle to rated conditions. This occurred the first time through the idle to rated cycle of Step 5, where the first pump was able to complete two full cycles. One indication of system issues can be seen at around 14605 seconds. There is a rapid loss of rail pressure followed by an increase and slow return to normal pressure (~8000 psi for idle condition) prior to the ramp. Once the ramp command was given, speed was increased by the VFD, but never reaches the full rated speed of 2400 rpm. As the pump speed passed 1700 rpm, the motor power rapidly rose from near 4kW to a briefly measured peak of 20kW before catastrophic pump failure occurred. At this point, it was confirmed that the pump failure was not an isolated event and should be considered valid. Following this, each fuel was tested to failure in one pump prior to a test change rather than confirming the result using a second assembly. Safety shutdowns were incorporated into the test programming in an effort to stop the VFD when output power was measured above 4.5kW. This, in some cases, prevented component destruction which can be seen in Figure 22.

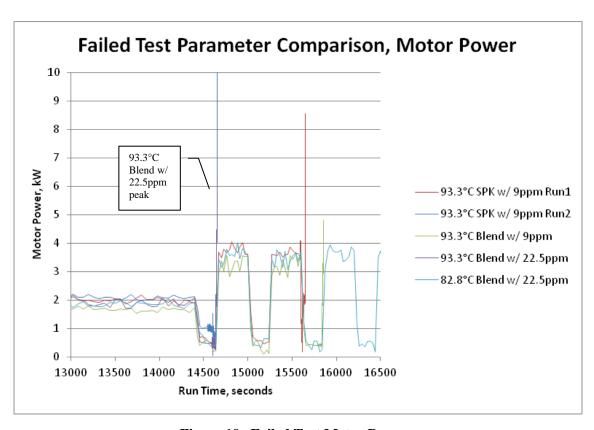
Figure 19. Failed Test Motor Power

The required electrical power for the motor to drive the high pressure pump for the tests resulting in premature failure of the high pressure pump are shown in Figure 19 along with the final 50/50 blend evaluation with 22.5 ppm DCI-4A at 82.8°C for comparison. Data shown is at a rate of 10 Hz immediately prior to failure, and at one log per minute aside from that.

Through 14400 seconds of Run Time, the data shown is for Step 4, full throttle and 75% speed. Following this the program enters Step 5 as previously described. Aside from the first 93.3°C SPK with 9 ppm DCI-4A test, each pump failed while ramping from idle to rated conditions, and all within the early stages of the same step. The 20 minute window within which failures occurred represents 0.083% of the 400 hour cycle. Prior to failure, each system showed consistent power requirements through the end of Step 4.

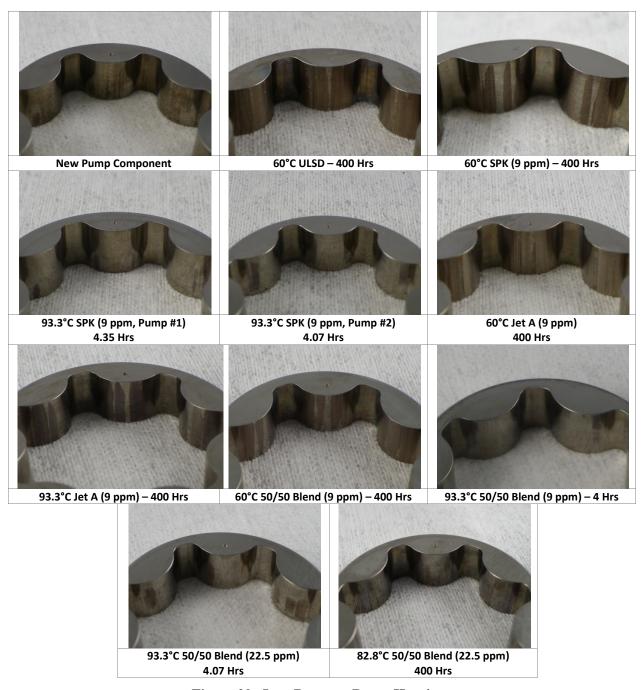
Figure 20. Low Pressure Pump Housing

Figure 20 shows the condition of the low pressure pump housing at the end of each test.

Each test that completed the full 400 hours of operation showed some amount of wear on the pump ring. Based upon appearance, the ULSD and high temperature Jet A with 9 ppm DCI-4A tests showed the largest wear patterns. Despite a limited number of operational hours, there were well developed areas of wear on a number of the failed tests as well. While the pumps typically failed in a somewhat dramatic fashion, the marks visible do not appear to be due to heavy shock loading or impact. In no instance were the components shown difficult to remove from the pump at the end of test. Existing in a relatively low pressure area of the pump, it would not be expected that this component would suffer major damage over time or be the initial cause of pump failure with the use of poor lubricity or viscosity fluids.

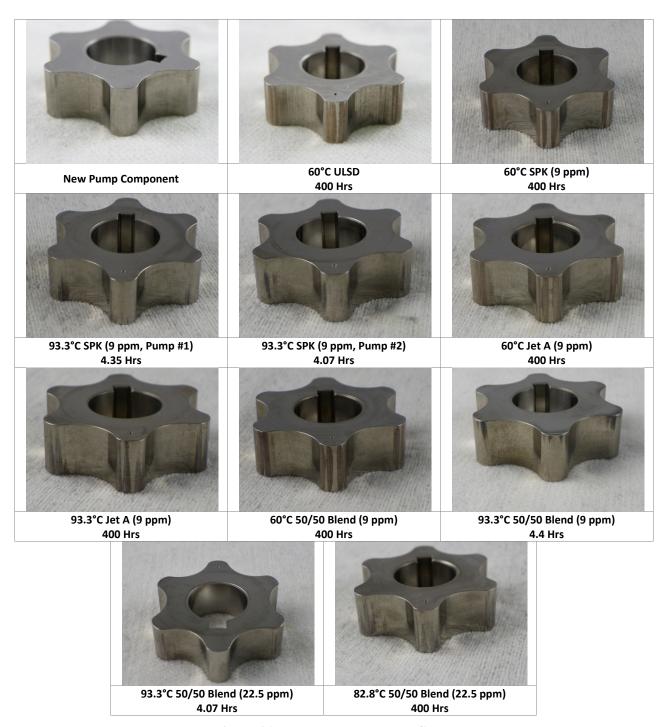
Figure 21. Low Pressure Pump Gear

Figure 21 shows the condition of the low pressure pump gear at the end of each test. The condition of the low pressure pump gear matched closely with that of the housing ring. In this case, even the unused component has some very minor signs of wear, likely due to a performance check following manufacturing. Again, the duration of test appeared to be the driving factor for the formation of a pronounced wear scar. There is wear visible along the side face of the gear, however this appears to be minor compared to the marks on the tooth edges. With continued operation and wear, this location has the potential for impacting pump performance. While the curved profile of the gear teeth limit the risk of tooth failure due to loading, at some point the wear present may result in seizure of the pump ring around the gear. This failure mechanism would result in either overwhelming load placed on the pump camshaft, or a failure of pump housing integrity. Another possible result of further wear would be excessive leakage from one chamber to the next as the ring rotates. Within insufficient sealing, the fuel would not be properly pressurized and forced into the main pump body or high pressure areas. This might result in a loss of desired rail pressure and inadequate lubrication and cooling of pump components.

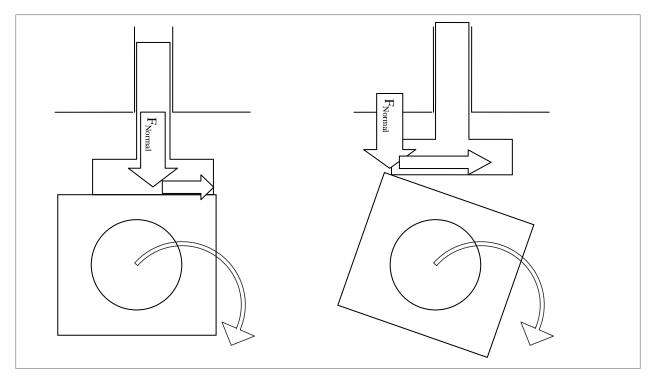
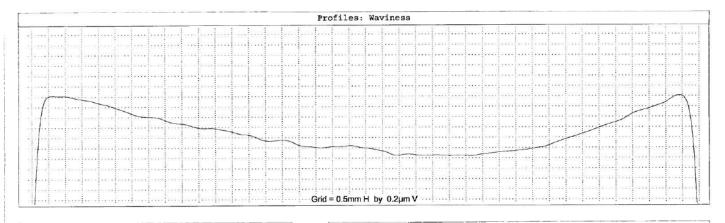
Figure 23. Plunger Failure

This surface is the contact location between the high pressure plunger and the ring cam. Components shown for the 93.3°C SPK tests are lacking the plunger shaft visible for the other tests. In these instances, the shaft snapped off within the pump head and the section of the component visible was able to move freely in the main pump housing. Damage on the edge of the slider can be seen for all testing the prematurely ended. This is the result of the ring cam seizure on the cam shaft causing it to produce all contact forces at the corner edge. This is illustrated in Figure 23.

The ring cam rotation, Figure 5, would cease to occur in the proper orientation with full contact between the flat, sliding surfaces (shown on left). When all contact forces were transferred through the outer edge of the plunger (right), this caused the head to snap off. Under typical operation, the normal force acting between the two surfaces is a combination of spring force, sliding friction along the plunger shaft, and rail pressure that must be overcome to force fuel from the pumping chamber. The side loading is the result of the friction produced by this normal force and the coefficient based upon surface finish of the plunger head and ring cam using the fuel as a lubricant. These forces are spread over the entire contact area and reduce effects of imbalanced loading as the plunger travels through the pump head. In the case of component failure, the entire contact area had moved to one edge of the plunger head.

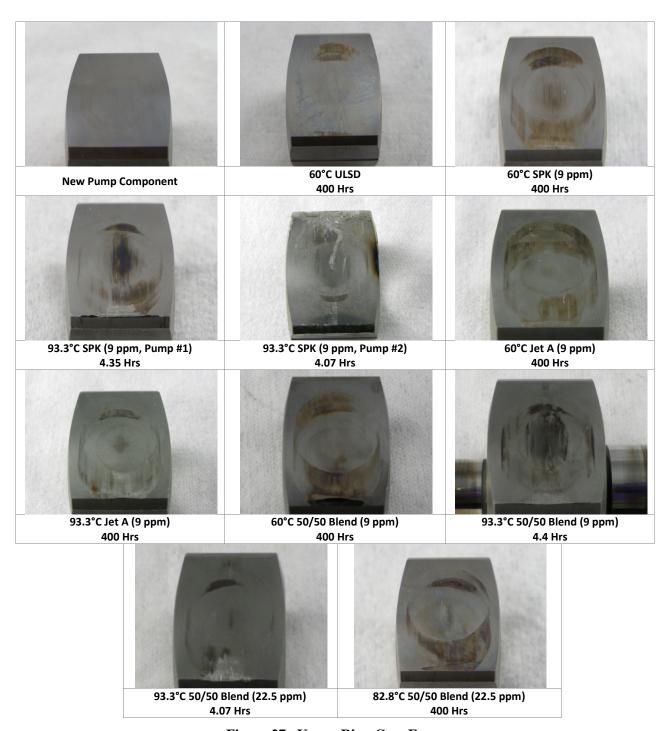
Figure 27. Upper Ring Cam Face

Figure 27 shows the condition of the upper ring cam face at the end of each test. All cases, regardless of fuel, experienced some level of wear on the ring cam faces which sliding contact occurred. The tests which ended prematurely have a noticeable mark on one edge. This matches the damage noted from the upper plunger sliding face. The wear at this location appears in some cases to be due to impact rather than sliding contact over time. As the plunger seized in its bore, or the ring cam seized onto the camshaft, the pump may have been able to complete a few cycles without proper contact between the two components. As the ring cam began upward travel, an impact may have occurred at this corner. Scoring across the face of the second 60°C SPK test with 9 ppm DCI-4A was due to debris in the pump body as the failure occurred. A contrast can be seen between the ULSD test and those conducted on the aviation and synthetic fuels. The condition of the ULSD ring cam face indicates that an adequate level of lubrication was maintained between the majority of the two surfaces. While there are signs of wear in the location the plunger reached at maximum horizontal travel of the ring cam, this mark is relatively minor compared to those formed by all other fuels. Even over the duration of the four hour long failed tests, component conditions indicate a high level of boundary contact resulting in the scuffing and grinding seen.

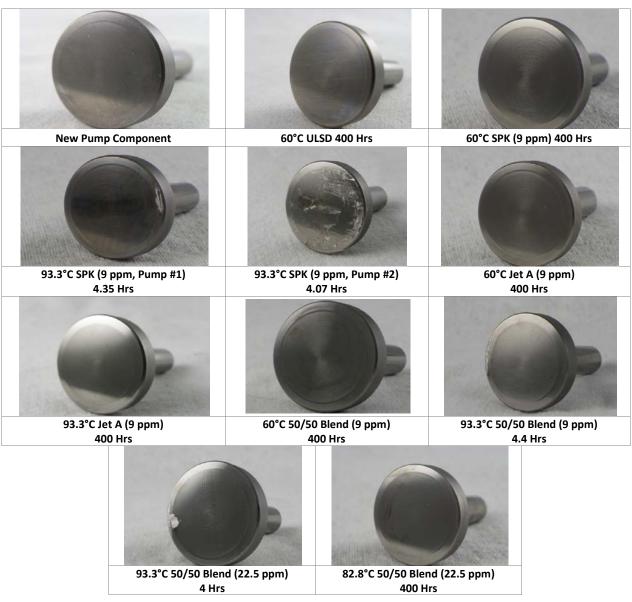
Figure 28. Lower Plunger Face UNCLASSIFIED

Figure 28 shows the condition of the lower plunger face at the end of each test. The condition for each component is very similar to that of the upper plunger. The exception to this are tests which experienced a cracked upper plunger shaft, an event which did not occur for any of the lower plungers. The gouging seen in the second iteration of the 93.3°C SPK test with 9 ppm DCI-4A is due to debris which formed in the pump body and were ground between the plunger and cam ring.

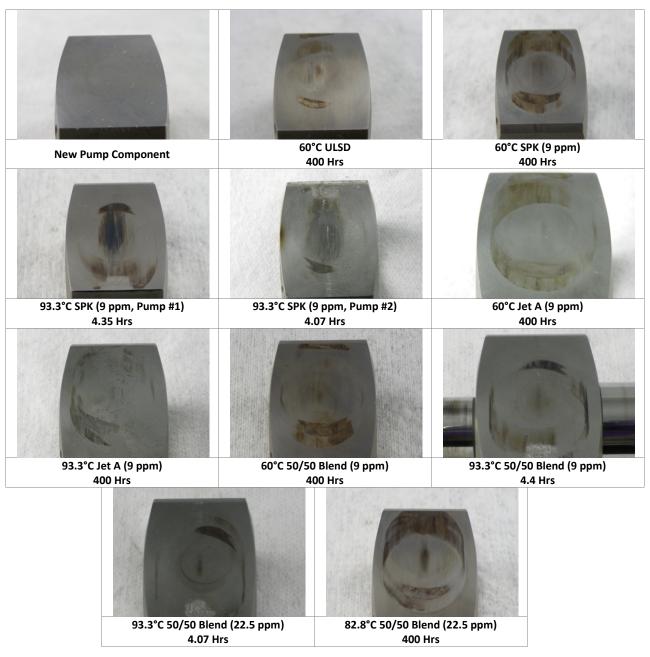
Figure 29. Lower Ring Cam Face

Figure 29 shows the condition of the lower ring cam face at the end of each test. As with the plunger, the condition of the lower ring cam is similar to that of the upper side.

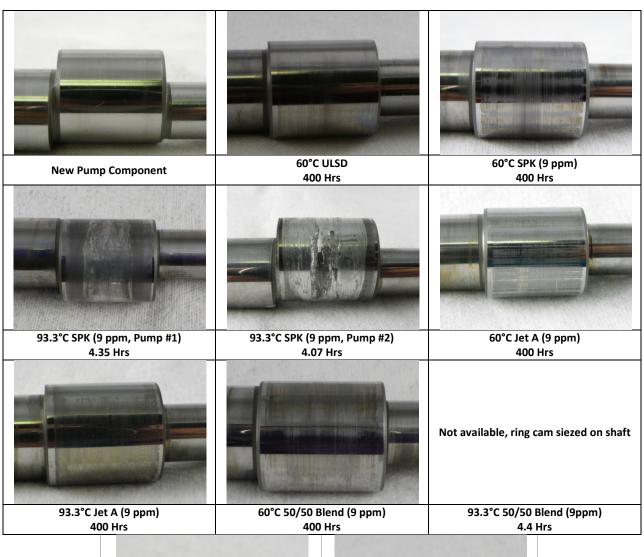
Figure 31. Camshaft Lobe

Figure 31 shows the condition of the cam shaft lobe at the end of each test. The condition of the lobe for each evaluation is generally better than the corresponding bushing. The most common feature to develop on the surface of the lobe was a series of scuff marks. These formed on the side of the lobe which corresponds to the heaviest loading as the plunger is driven into the bore. In most cases, some level of the original polish was maintained. Only the high temperature SPK testing showed extensive damage, likely due to the catastrophic failure of the pump. This interface between the camshaft lobe and the ring cam bushing appears to be the most sensitive area within the pump.

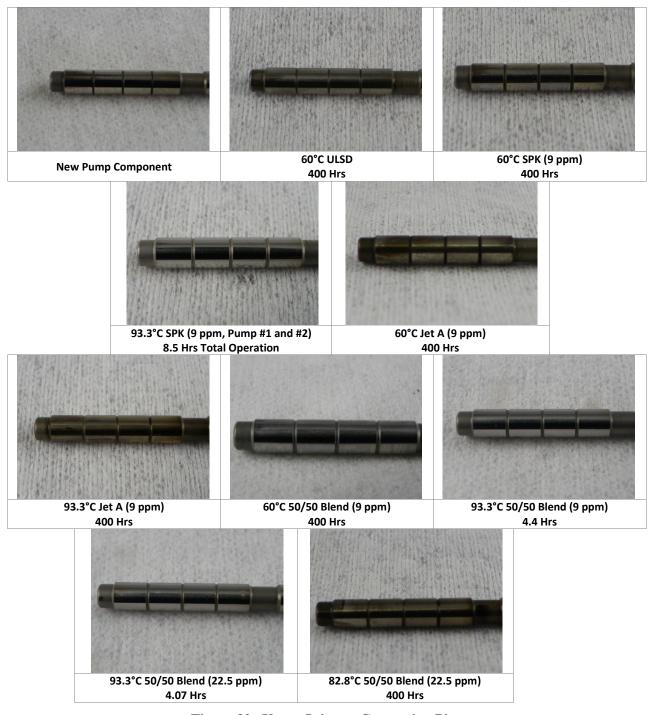
Figure 32. Upper Injector Connecting Pin

Figure 32 shows the condition of the upper injector connecting pin at the end of each test.

The only noticeable wear feature on this internal injector component is a small area of axial marking on the upper (left) end. Formation of these lines occurred on all testing that reached the full 400 hours. There appears to possibly be a light tempering effect, based on color, occurring in the injectors for the components which were evaluated at the higher fuel temperatures. The 93.3°C Jet A with 9 ppm DCI-4A and 82.8°C 50/50 Blend with 22.5 ppm DCI-4A tests have a darker yellow/straw appearance consistent with steel tempered near 220 to 230°C. The fuels evaluated at lower temperatures show a slight tingle of yellow which may begin to form in steel heated to 215°C. While no direct measurement is available for the internal injector temperature, the fuel temperature downstream of the injectors, after some cooling would have occurred, is shown in Figure 33.

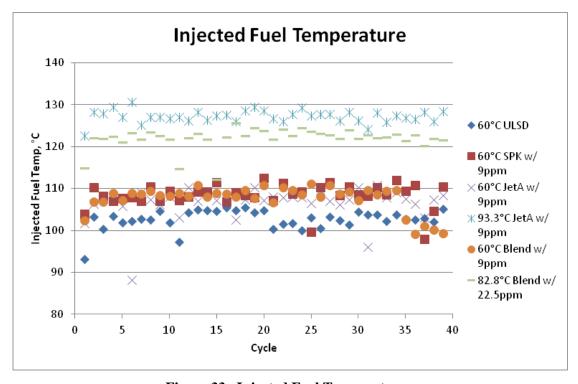
Figure 33. Injected Fuel Temperature

It would not be unrealistic for the highly pressurized fuel within the injector body to experience localized temperatures much greater than those measured downstream. While no issues were noted with the injector components at the temperatures tested, if fuel was supplied above 93.3°C some considerations should be given to changes in material properties over time due to heating.

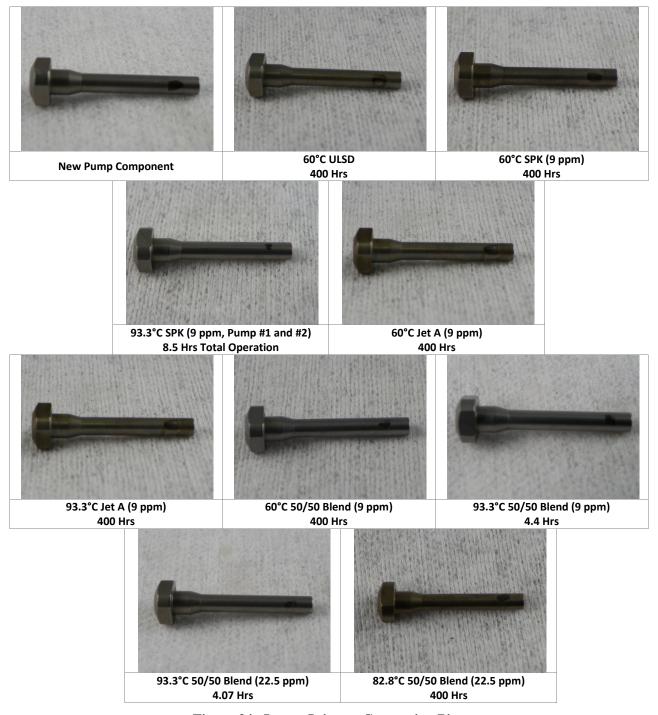
Figure 34. Lower Injector Connecting Pin

Figure 34 shows the condition of the lower injector connecting pin at the end of each test.

The connecting pin which sits just above the injector needle showed only one spot of wear. This can be seen on the right side of each image in Figure 34 including that of the unused component. As with the upper connecting pin, there is appearance of color on the high temperature test components. This item does not appear to be a point of concern for the function of the injector assembly with any of the fuels evaluated.

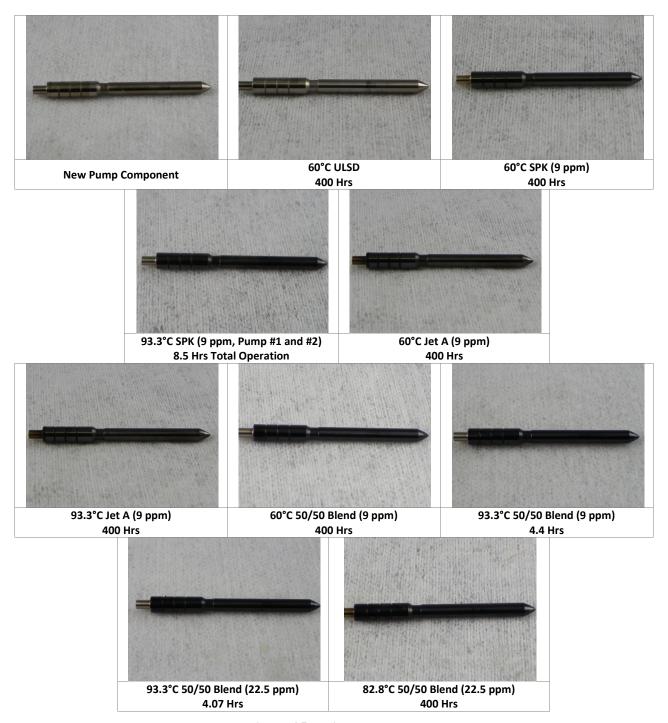
Figure 35. Injector Needle

Figure 35 shows the condition of the injector needle at the end of each test. There appeared to have been a hardware change made by the manufacturer to add a surface treatment to the needle between the first and subsequent tests. Hardware was obtained through a local supplier at two different times for the program, once during the design and installation phase of the fuel system and again once the system was functional. The components used in the ULSD test were from the first set of parts received while all other injectors arrived at a later date. The dark, nearly black, appearance was consistent for each injector regardless of test length and neither solvent nor light scraping removed the finish. The coating change was likely an effort to reduce the effects of long-term wear around the seat of the needle and the injector tip. Leakage between the sealing face of the needle and the injector could result in poor engine performance, increased fuel consumption, and failure to comply with emissions targets. Similar coatings have been noted on internal injector components in other HPCR systems tested to improve hardness and reduce friction. There did not appear to be any degradation of the needle during testing.

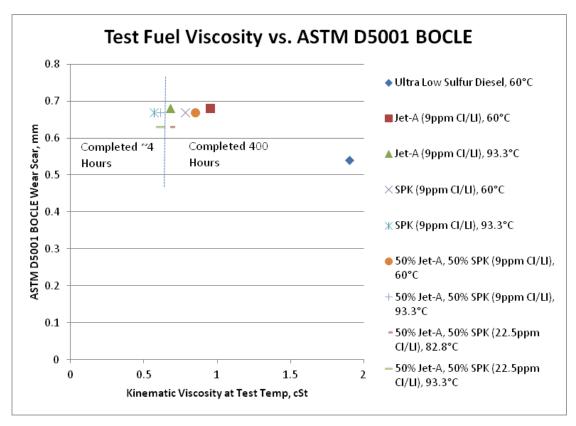
Figure 36. Viscosity and BOCLE Comparison

Results from the system evaluated indicated a sensitivity to synthetic aviation fuels not seen in other modern HPCR equipment. Post-test component analysis indicated that the critical area for system failure was the interaction between the ring cam and camshaft within the high pressure pump. A driving factor for the ability of the pump to survive the test was the fuel viscosity at the test temperature. Figure 36 and Figure 37 show the fresh fuel BOCLE and HFRR results compared with the kinematic viscosity at test temperature. For each figure, there was a minimum viscosity value below which the pump experienced the previously described failure.

The minimum value for fuel viscosity which resulted in a completed test was 0.68 cSt. Using the 50/50 Blended fuel with the maximum treat rate, a difference of 10.5°C in temperature increased the test duration by nearly 396 hours. The same fuel in moving from the minimum to maximum treat rates of DCI-4A had no meaningful change in test duration. For the future use of the system in military applications, fuel selection should take into consideration the expected vehicle tank temperatures. Operation in lower temperature environments may allow for the use of higher blend rates of low viscosity synthetics while high ambient may require solely petroleum based fuels. These results may be summarized as follows:

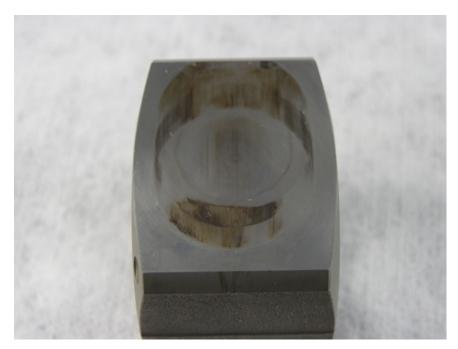
Figure C-11. Ring Cam - Bottom

Post-test tear disassembly of the pump and injectors was performed to evaluate wear operating on SPK at 60°C inlet with 9 ppm DCI-4A. The following figures highlight various areas of the pump and injectors.

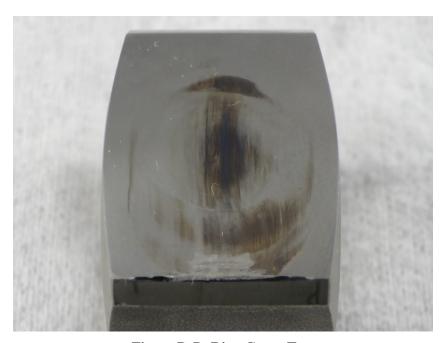
Figure D-7. Ring Cam - Top

Post-test tear disassembly of the pump and injectors was performed to evaluate wear operating on SPK at 93.3°C inlet with 9 ppm DCI-4A. The following figures highlight various areas of the pump at the time of failure. Injectors were not removed due to use with a second pump at the same fuel conditions.

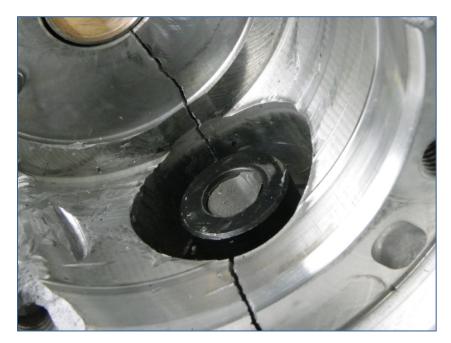
Figure E-9. Plunger Shaft - Top

Post-test tear disassembly of the pump and injectors was performed to evaluate wear operating on SPK at 93.3°C inlet with 9 ppm DCI-4A. The following figures highlight various areas of the pump at the time of failure. Injectors were not removed due to use with a second pump at the same fuel conditions.

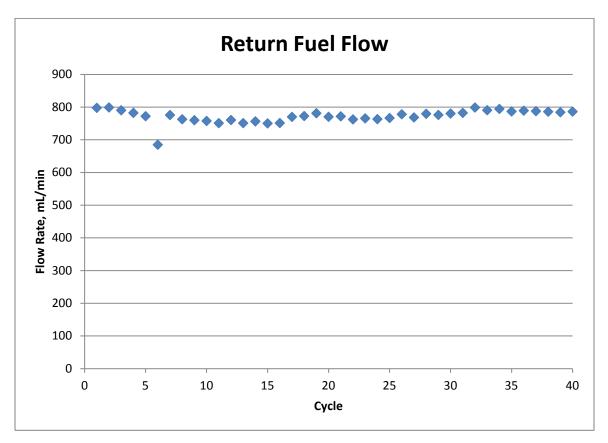
Figure F-4. Return Fuel Flow

Figure F-4 shows the return fuel from the injectors, rail, and high pressure pump. The loss of flow rate in cycle six is due to an issue with the system inlet temperature.

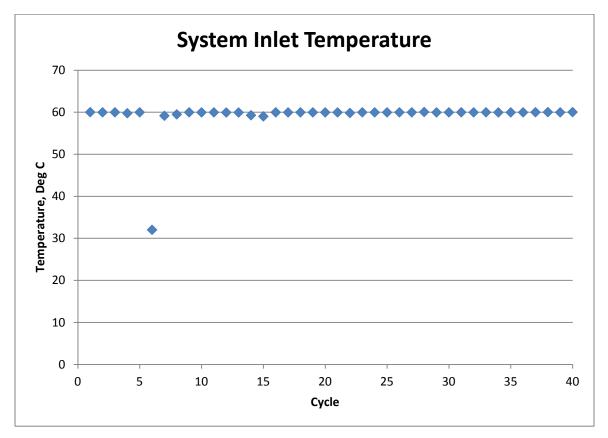
Figure F-5. System Inlet Fuel Temperature

Figure F-5 shows the system inlet temperature. This was controlled through a pulse-width modulated heater element. Temperature dropped during the 6^{th} cycle due to a faulty pressure switch safety on the heater control loop. This was corrected prior to the next cycle

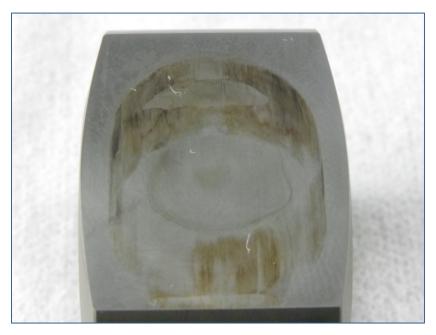
Figure F-9. Ring Cam - Top

Post-test tear disassembly of the pump and injectors was performed to evaluate wear operating on SPK at 60°C inlet with 9 ppm DCI-4A. The following figures highlight various areas of the pump and injectors.

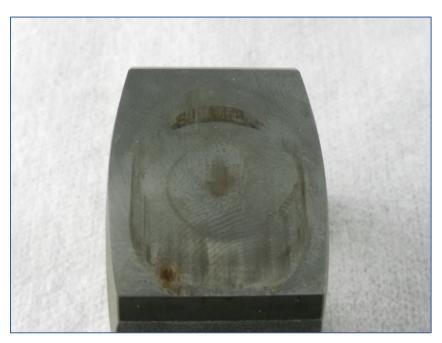
Figure G-9. Ring Cam - Top

Post-test tear disassembly of the pump and injectors was performed to evaluate wear operating on SPK at 60°C inlet with 9 ppm DCI-4A. The following figures highlight various areas of the pump and injectors.
